December 2023
Sun Vista/Sunlight Beach Water Consolidation Feasibility Study

Task 1 Summary Memorandum – Evaluation of Existing Sunlight Beach Water Association Water System

Prepared for:
Sunlight Beach Water Association

**Re: Sun Vista/Sunlight Beach Water Consolidation Feasibility Study
Task 1: Evaluation of Existing Sunlight Beach Water Association Water System**

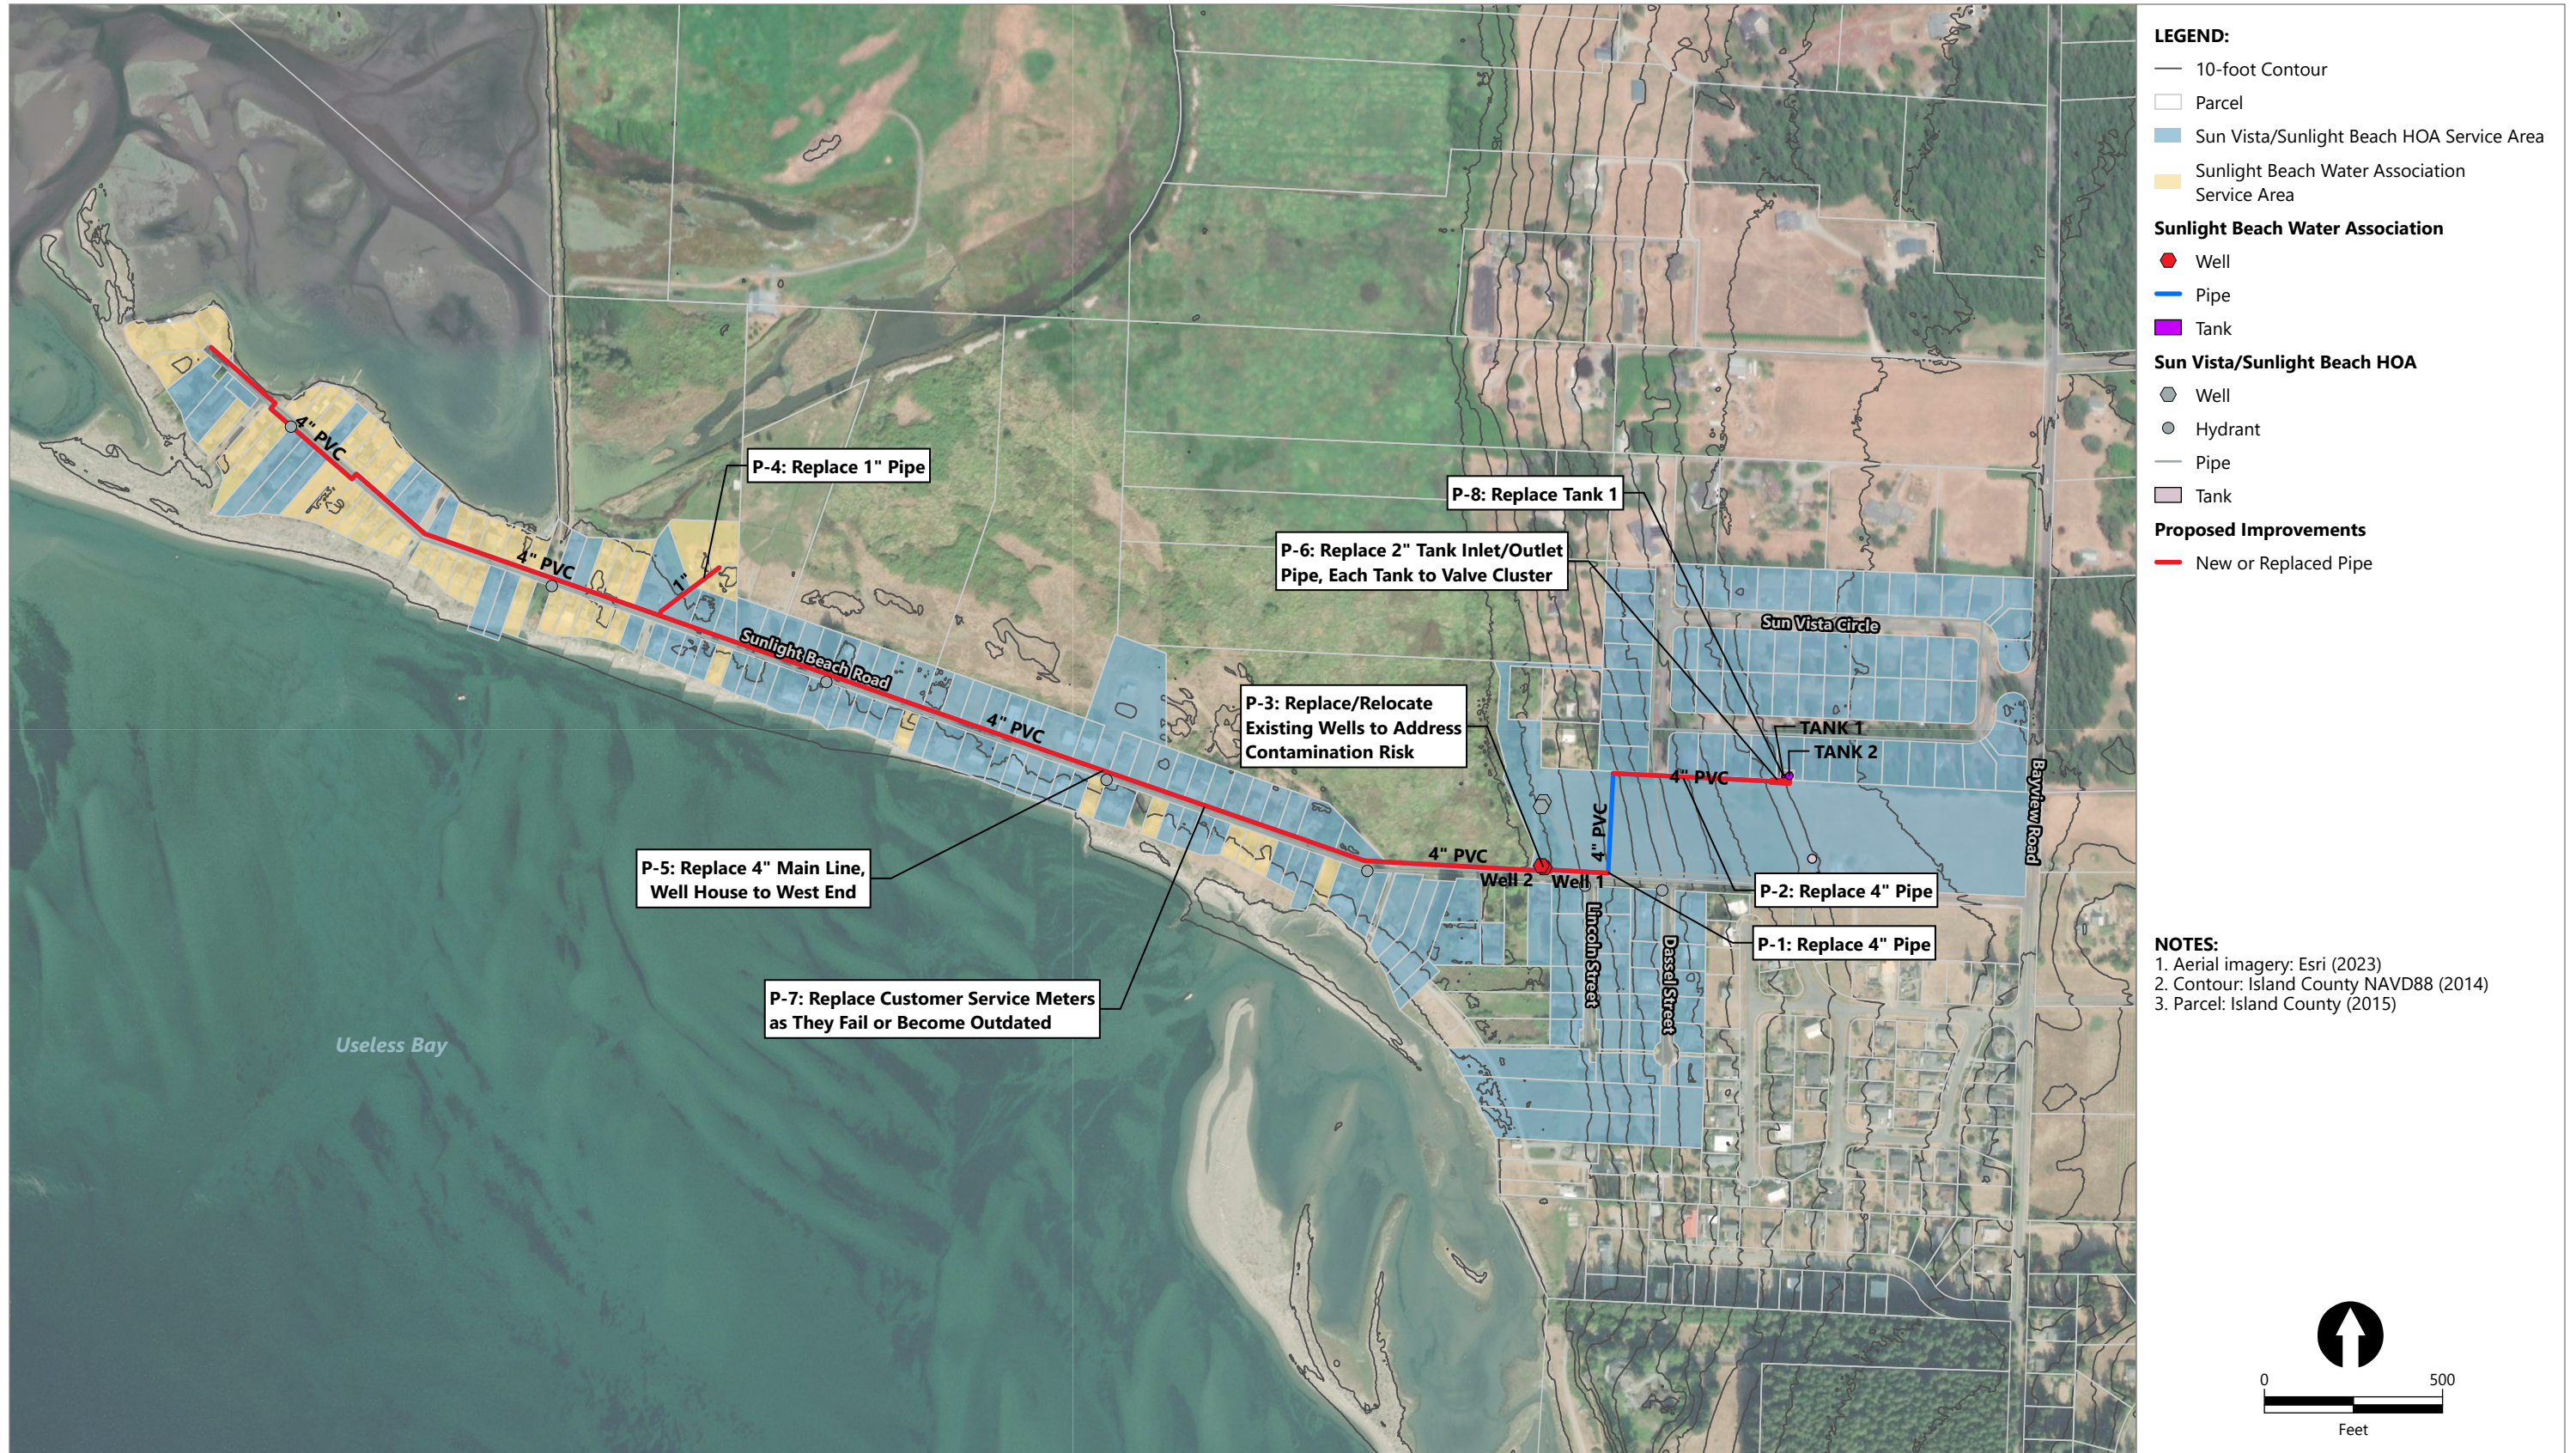
As noted previously, no capacity-related deficiencies were identified through the capacity analyses and hydraulic analysis. There is adequate source, storage, and distribution system capacity to meet the criteria set forth earlier in this memorandum under existing and projected water demand conditions. However, some of the water system infrastructure is aging and will likely require replacement or upgrade during the next 20 years. The need to replace aging infrastructure has been evaluated and recommended facility upgrades and replacements are included in the prioritized list of improvements recommended below.

Project ID	Description	Targeted Year for Completion
P-1	Replace the segment of the existing 4-inch PVC pipeline that conveys water from the wells to the storage tanks between the well house and the 90-degree bend where the pipeline runs north through an easement across the Kohwles property. This pipe was not replaced as part of a realignment completed in 1998 that relocated a portion of this pipeline. The pipeline was originally installed in 1968-1969 and will likely require replacement due to age and condition within the next 6 years.	2029
P-2	Replace the segment of the existing 4-inch PVC pipeline that conveys water from the wells to the storage tanks in the easement along the north property boundary of the Kohwles property to the valve cluster located within 66 feet of the storage tanks. A portion of this pipe was not replaced as part of a realignment completed in 1998 that relocated a portion of this pipeline. The pipeline was originally installed in 1968-1969 and will likely require replacement due to age and condition within the next 6 years.	2029

P-3	Replace or relocate existing wells to address risk of bacteria, nitrate, and seawater intrusion contamination. This should be done prior to full development of the Kohwles property. Due to the limited space at the existing well site and location of the well downslope of septic systems that will be installed as part of the development of the Kohwles property, it is recommended that a new well be drilled at a different location, upslope of the Kohwles property and away from the potential risk of seawater intrusion. Relocation of wells will be evaluated in more detail as part of Tasks 2 and 3. A primary and secondary well should be considered for redundancy.	2029
P-4	Replace the existing 1-inch PVC pipeline that extends north from Sunlight Beach Road to serve Sunlight Beach Lots 67-1, 67-2, and 67-3. The age and condition of this pipe is unknown. It is anticipated that it will likely require replacement due to age and condition within the next 20 years.	2043

P-5	Replace the existing 4-inch PVC main pipeline in Sunlight Beach Road. The pipeline was original installed in 1986-1987. The condition of the pipeline should be monitored. It is anticipated that the pipeline may need to be replaced due to age and condition within the next 20 years.	2043

Project ID	Description	Targeted Year for Completion
P-6	Replace the 2-inch storage tank inlet/outlet pipes. The pipes were originally installed in 1982. The condition of these pipes should be monitored. It is anticipated that the pipes may need to be replaced due to age and condition within the next 20 years.	2043
P-7	Replace customer service meters as they fail or become outdated. The customer service meters were installed approximately 10 years ago. It is anticipated that up to one quarter of the meters will need to be replaced in the next 20 years.	2043
P-8	Replace or refurbish Tank 1. This tank was originally installed in 1947. It appears to currently be in good condition but is nearly 80 years old. The condition of the tank should be monitored. It is anticipated that the tank will need to be replaced or refurbished due to age and condition within the next 20 years. Inspection and monitoring may indicate that the life of the tank can be extended by relining and otherwise refurbishing components, rather than replacing the entire tank. Replacement would be challenging due to limited accessibility through an easement across private property.	2043
