Sun Vista/Sunlight Beach Water Consolidation Study Task 1 – Evaluation of Existing Systems

December 11, 2023

Sun Vista/Sunlight Beach HOA and Sunlight Beach Water Association Consolidation Feasibility Study

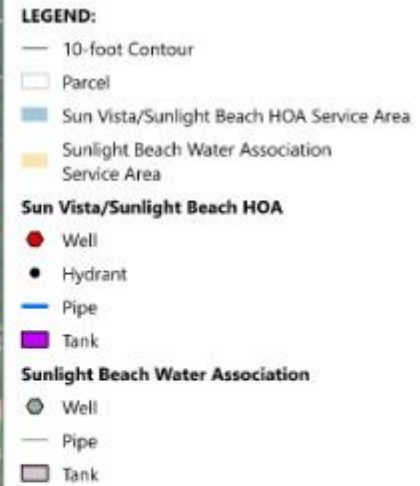
Existing SV-SLB HOA Water System

- 169 Existing Connections
- All Single-Family Residential
- ~18 Vacant Parcels
- Kohlwes Parcel Development

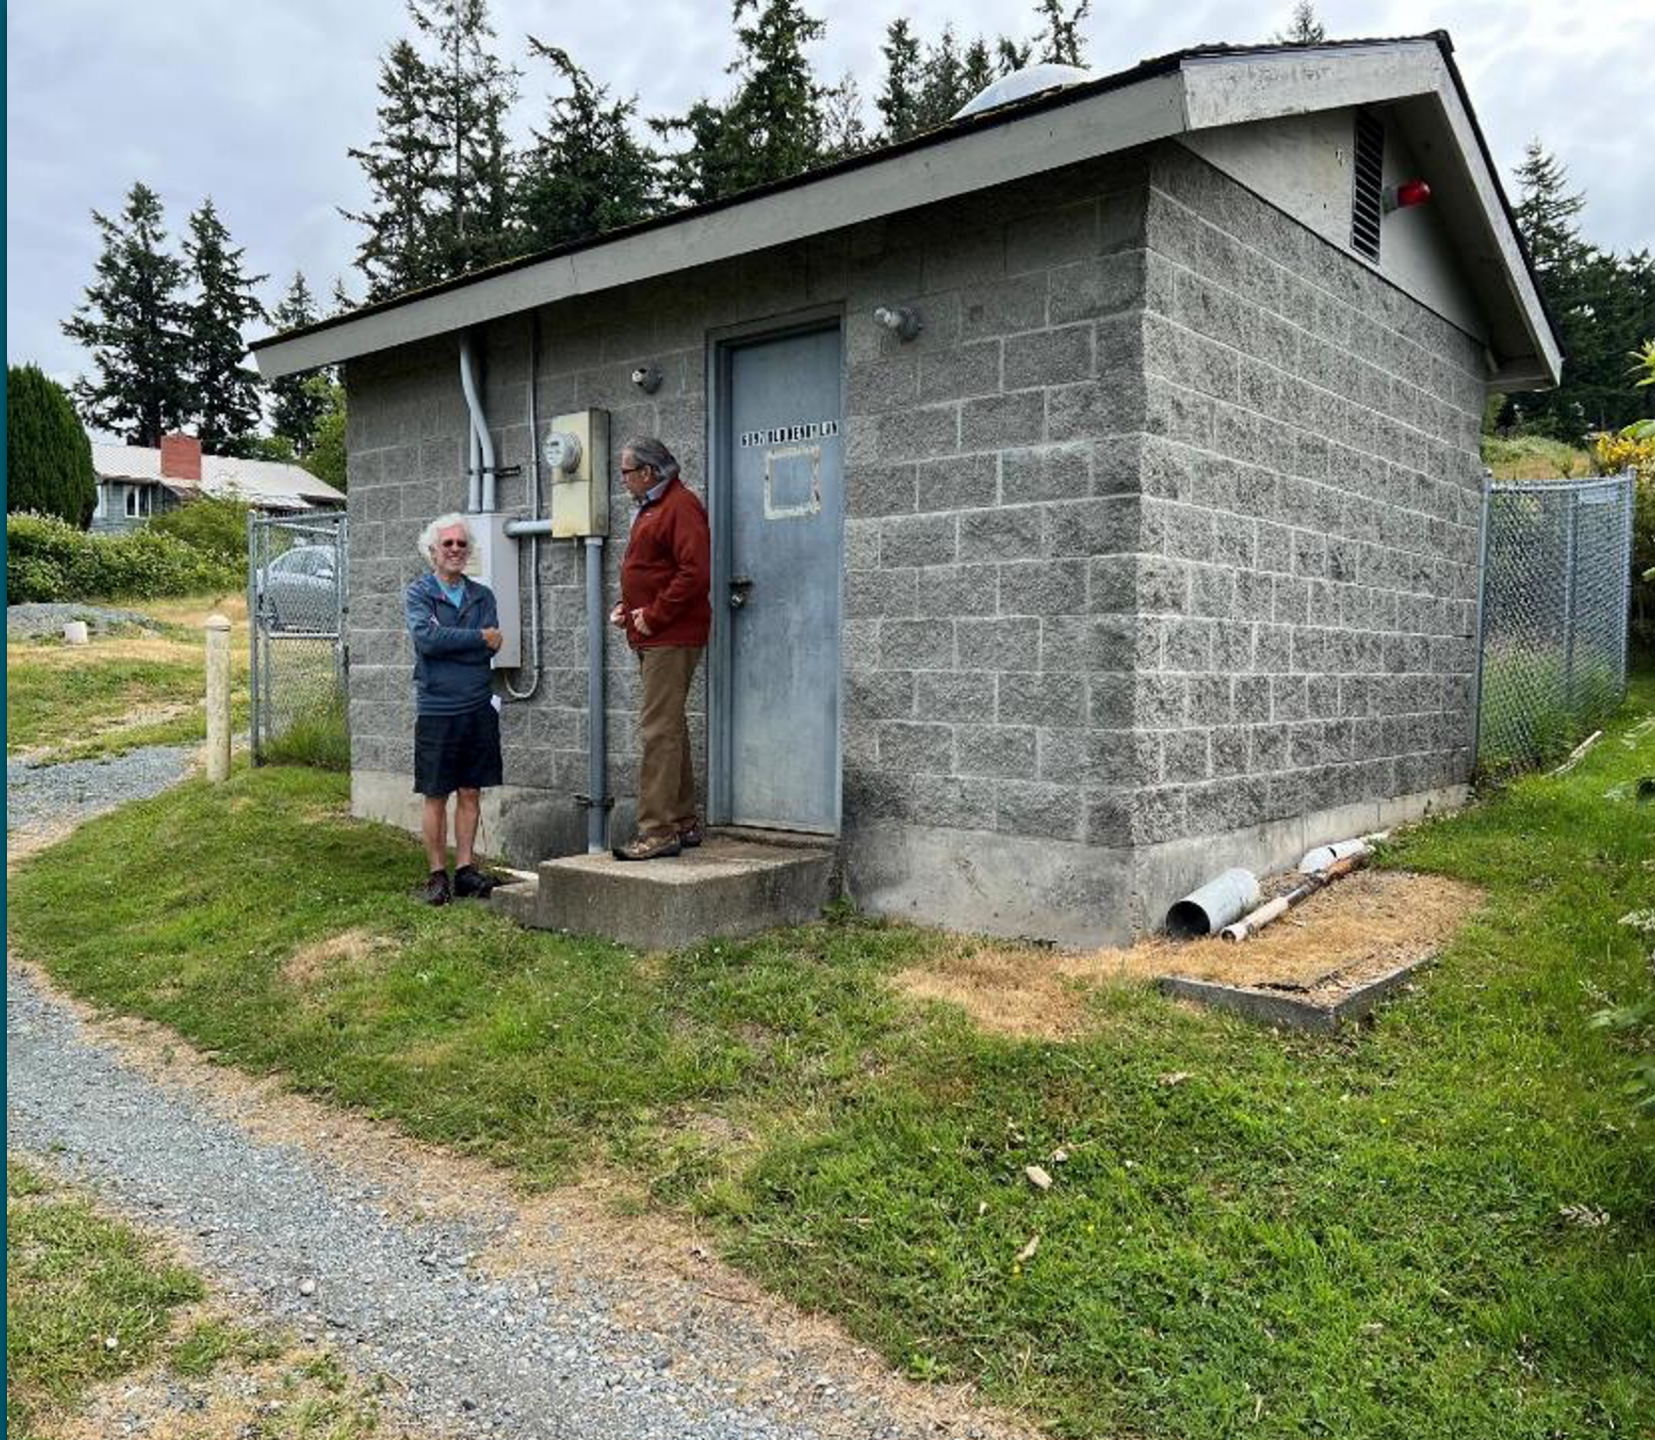
SV-SLB HOA Water System Well House

- Two Groundwater Wells
 - Well 1 (S01, Active)
 - 8-inch Well
 - 30 feet deep
 - 35 gpm capacity
 - Well 2 (S02, Active)
 - 8-inch Well
 - 50 feet deep
 - 78 gpm capacity
 - Both located in well house on Old Henry Lane
 - Chlorinated and Iron, Manganese, and Arsenic Filtration System
- Intertie with SBWA Water System

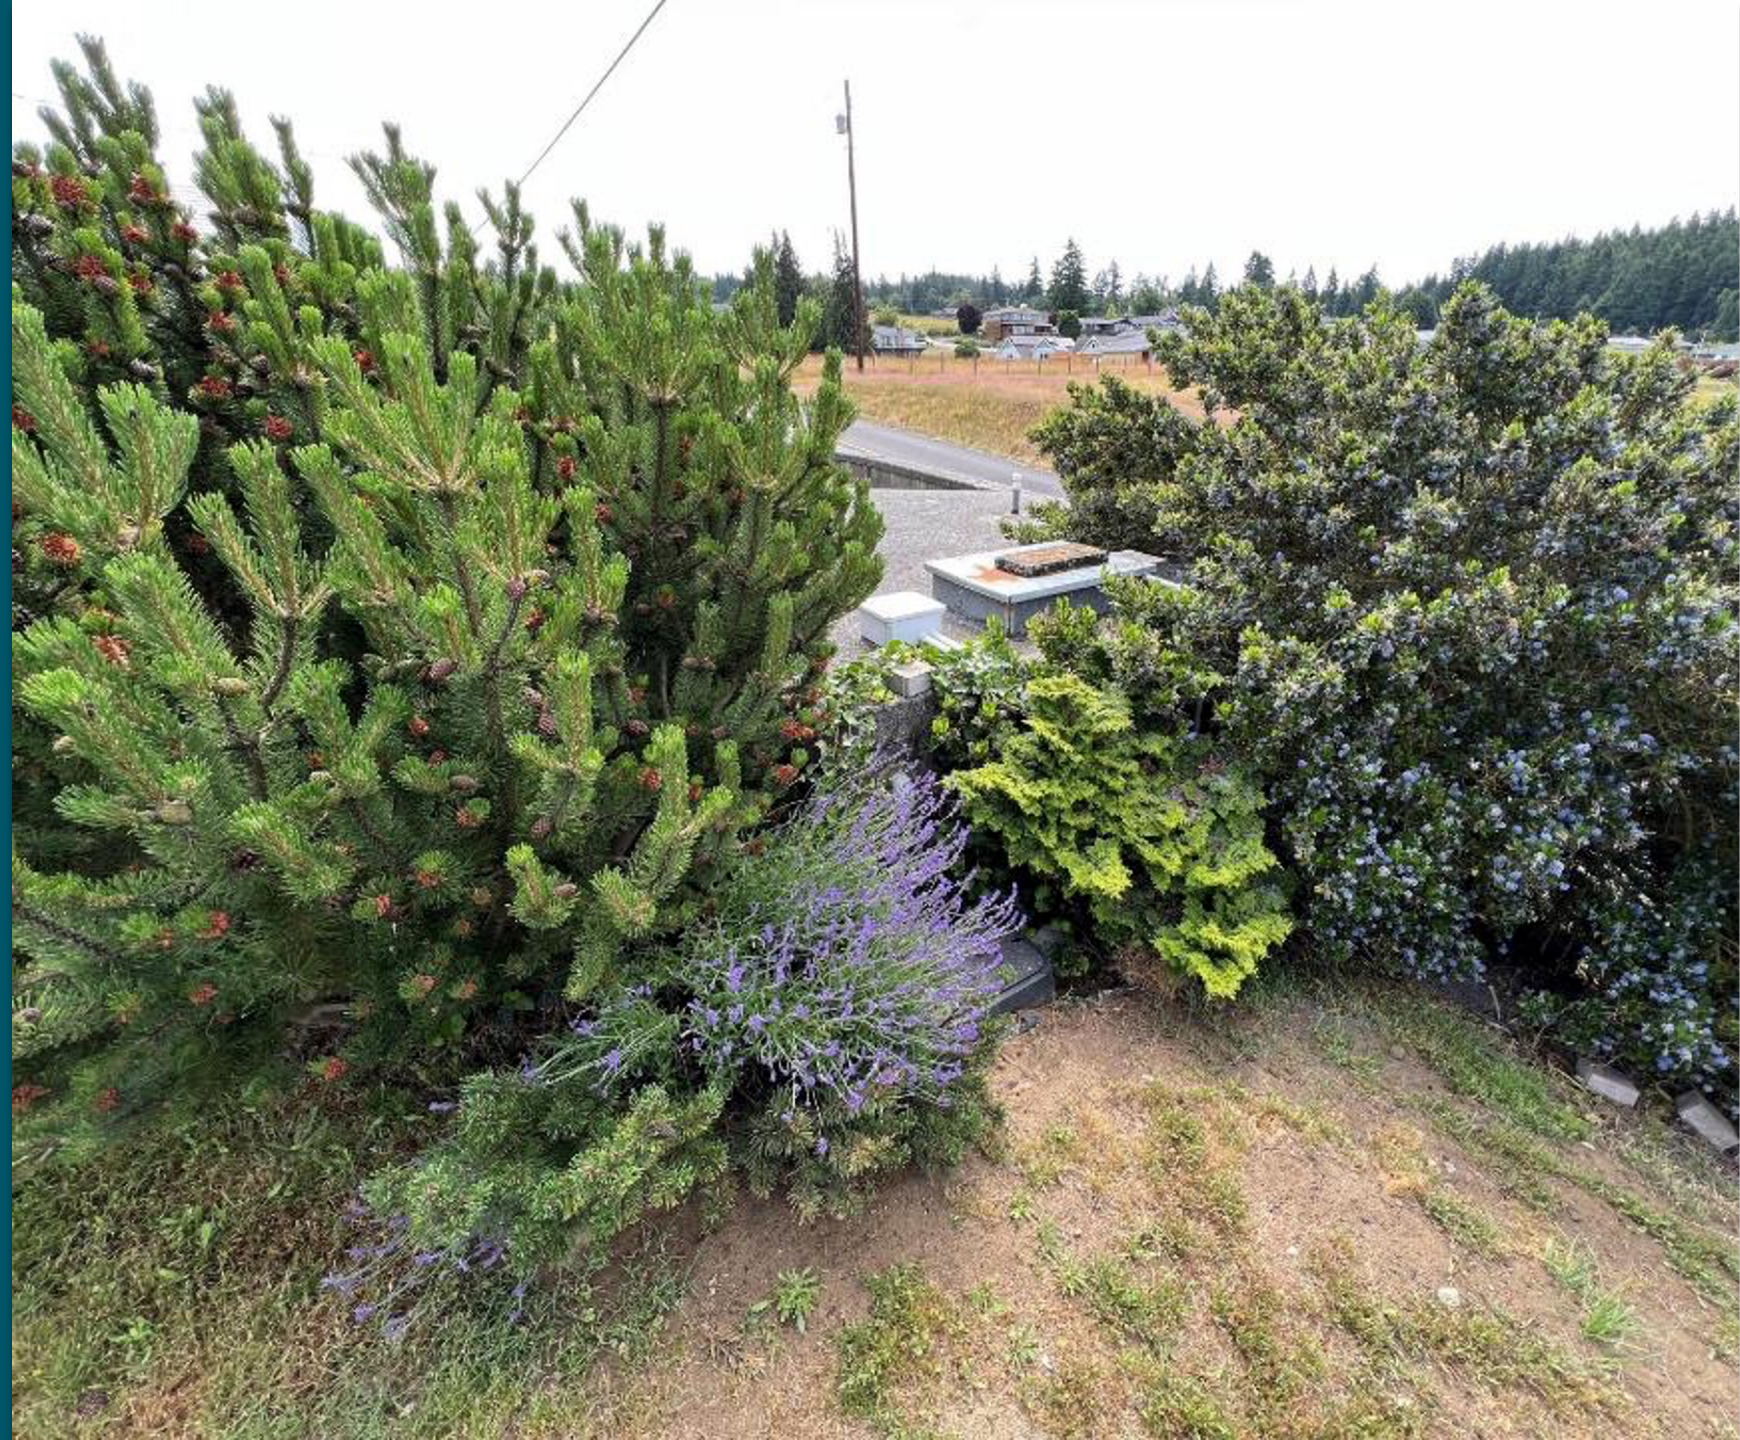
SV-SLB HOA
Water System
Tank 1

- Three Water Storage Tanks
 - Tank 1
 - 7,200 gallons
 - Octagonal reinforced concrete tank
 - Tank 2
 - 55,000 gallons
 - Circular reinforced concrete tank
 - Tank 3
 - 52,800 gallons
 - Circular reinforced concrete tank
 - Total Capacity = 115,000 gallons
 - Located in easement on north side of Sunlight Beach Road

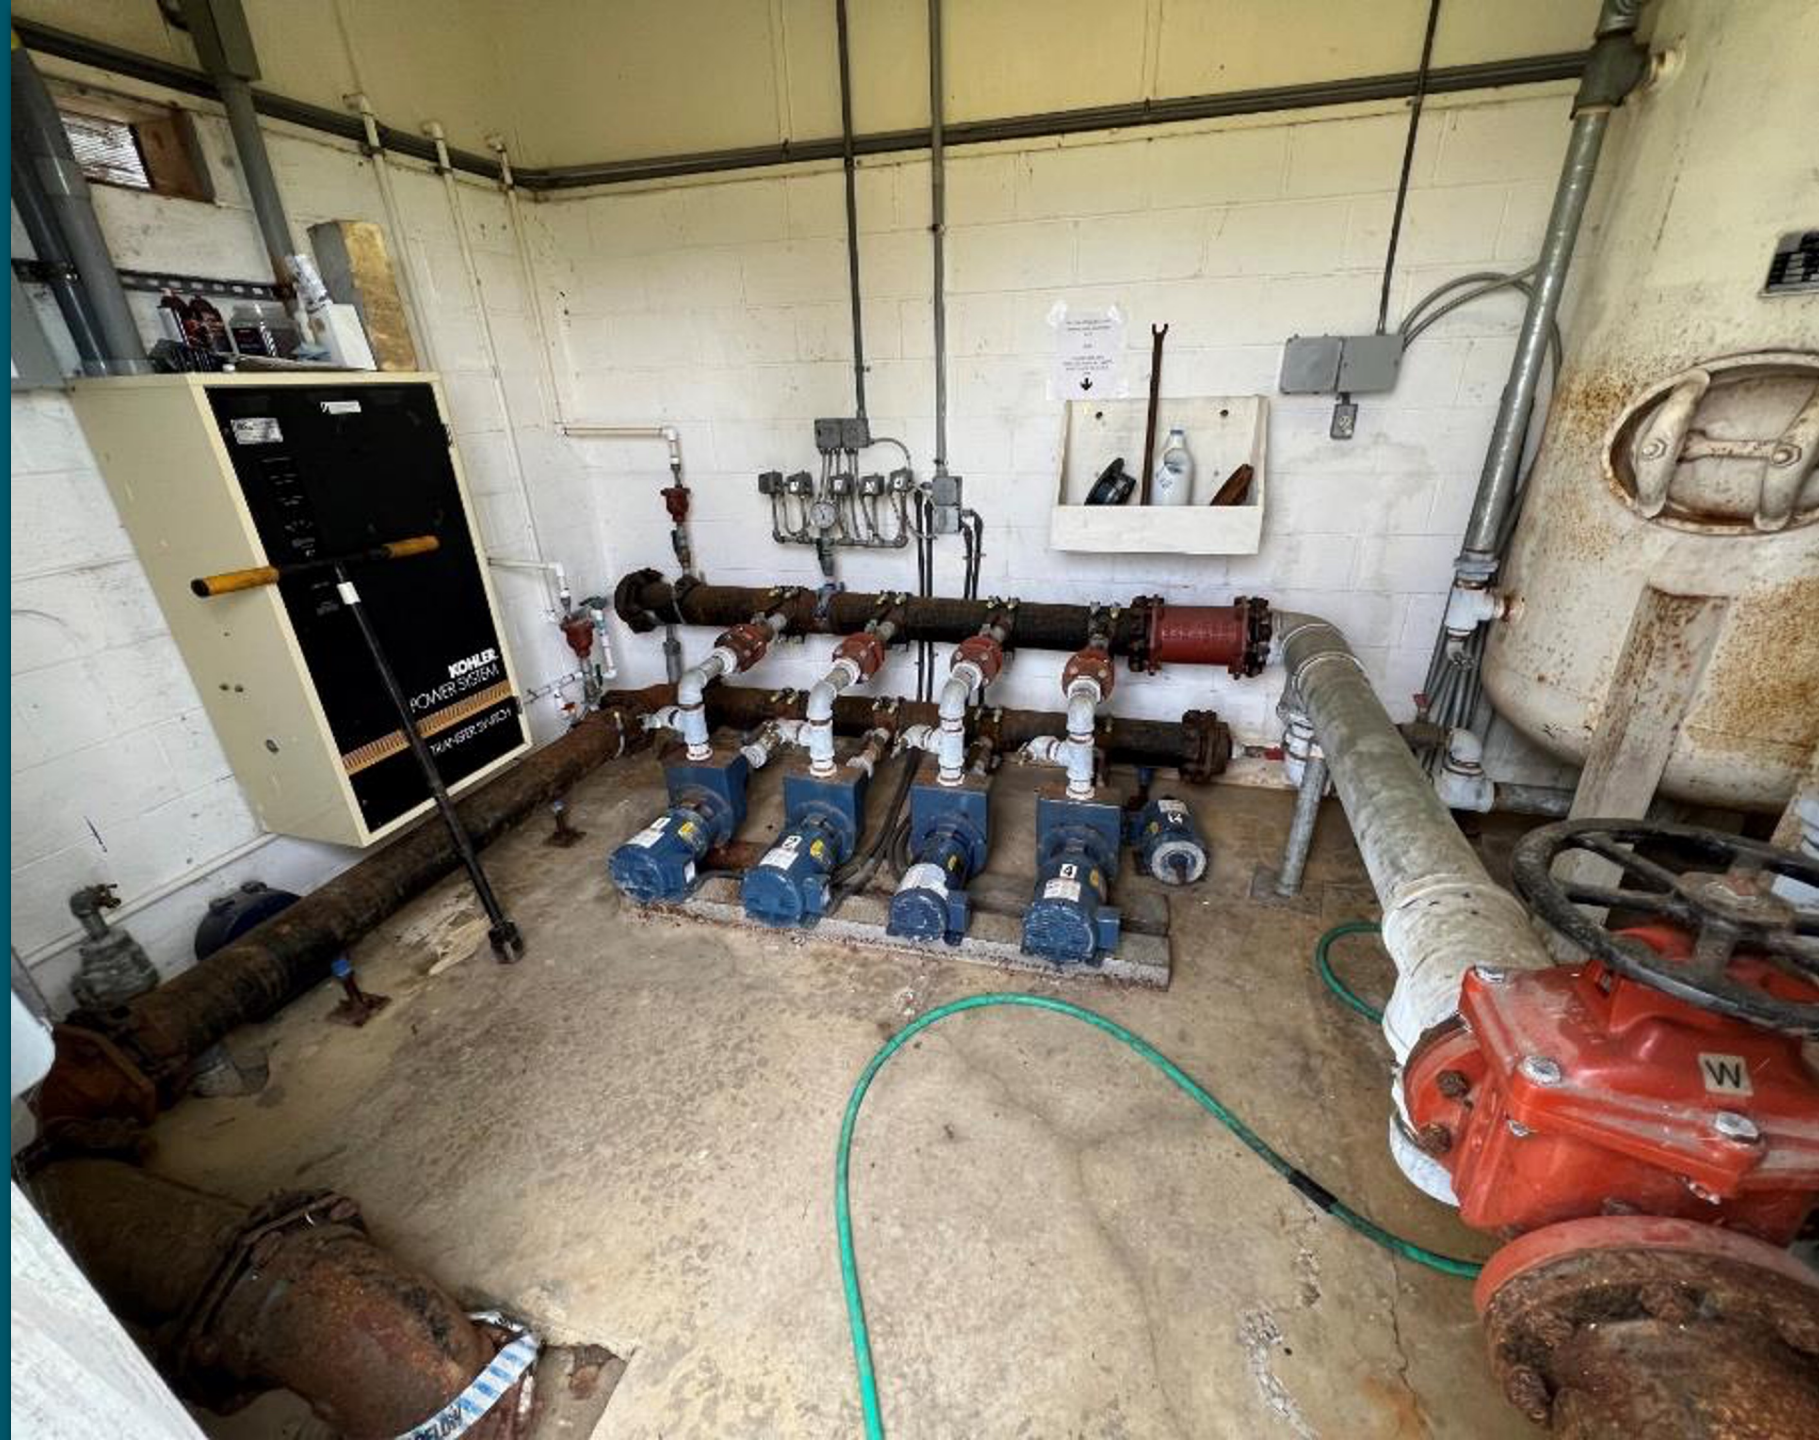
SV-SLB HOA Water System Booster Pump Station

- Booster Pump Station
 - Four 5-horsepower booster pumps
 - Pulls from water storage tanks
 - Delivers water to pressure system that serves the highest customer services, mostly along Sun Vista Circle and Dassel Street
 - Located adjacent to Tank 2

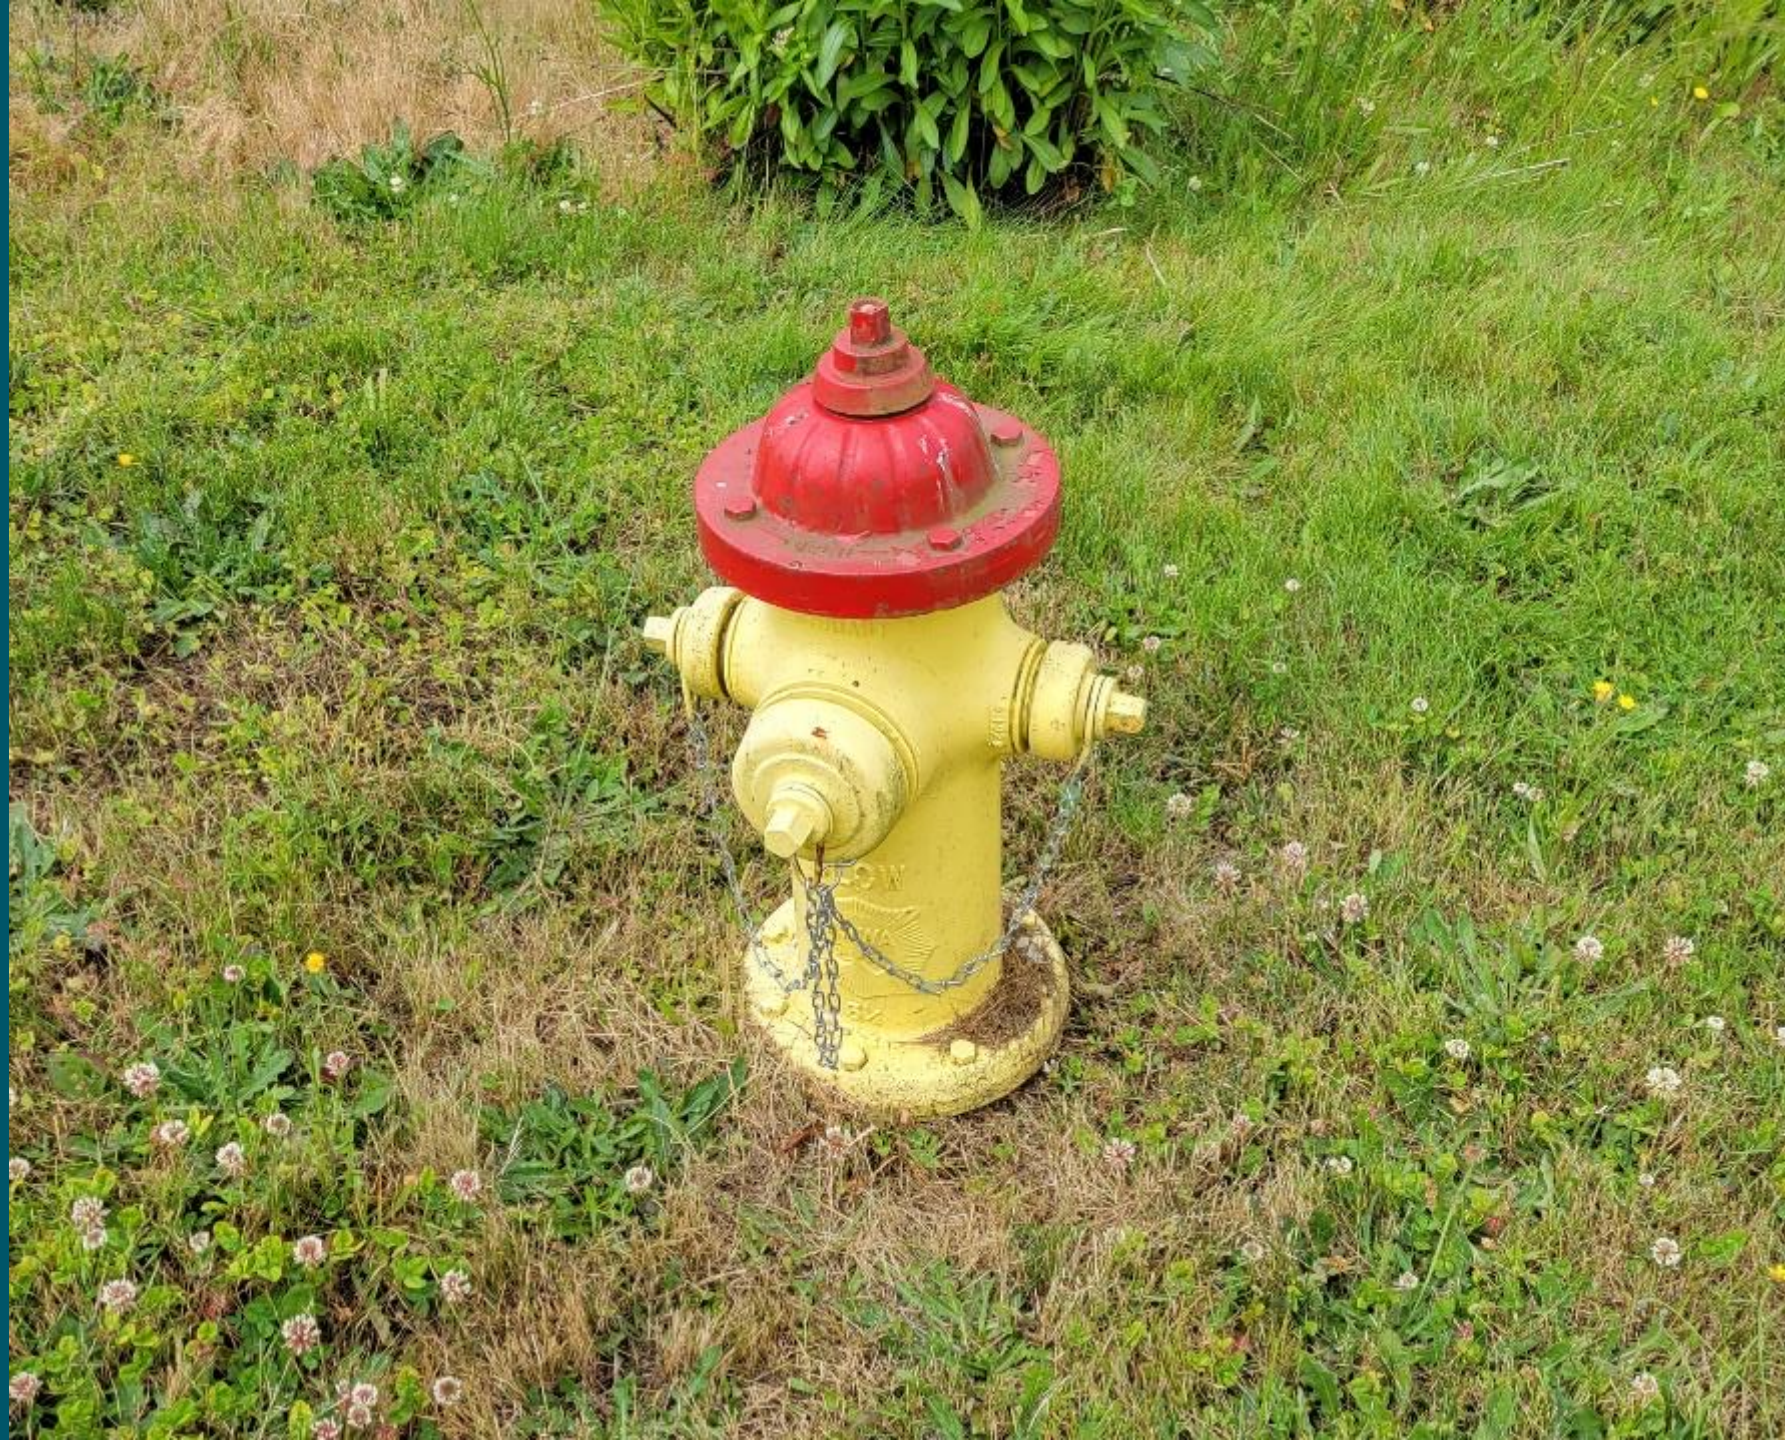
SV-SLB HOA
Water System
Hydrant

- 4-inch pipeline from well house to storage tanks
- 6-inch pressure pipeline with connections to 3-inch loop in Sun Vista Circle and 4-inch pipeline in Dassel Street
- 8-inch gravity pipeline in Sunlight Beach Road with connection to 4-inch pipeline in Lincoln Street and a few smaller pipelines
- Hydrants
 - Low flow (red cap) hydrants at Dassel Street, Lincoln Street, and Sun Vista Circle
 - Fire flow (fully yellow) hydrants along Sunlight Beach Road
 - Provide fire protection for both systems

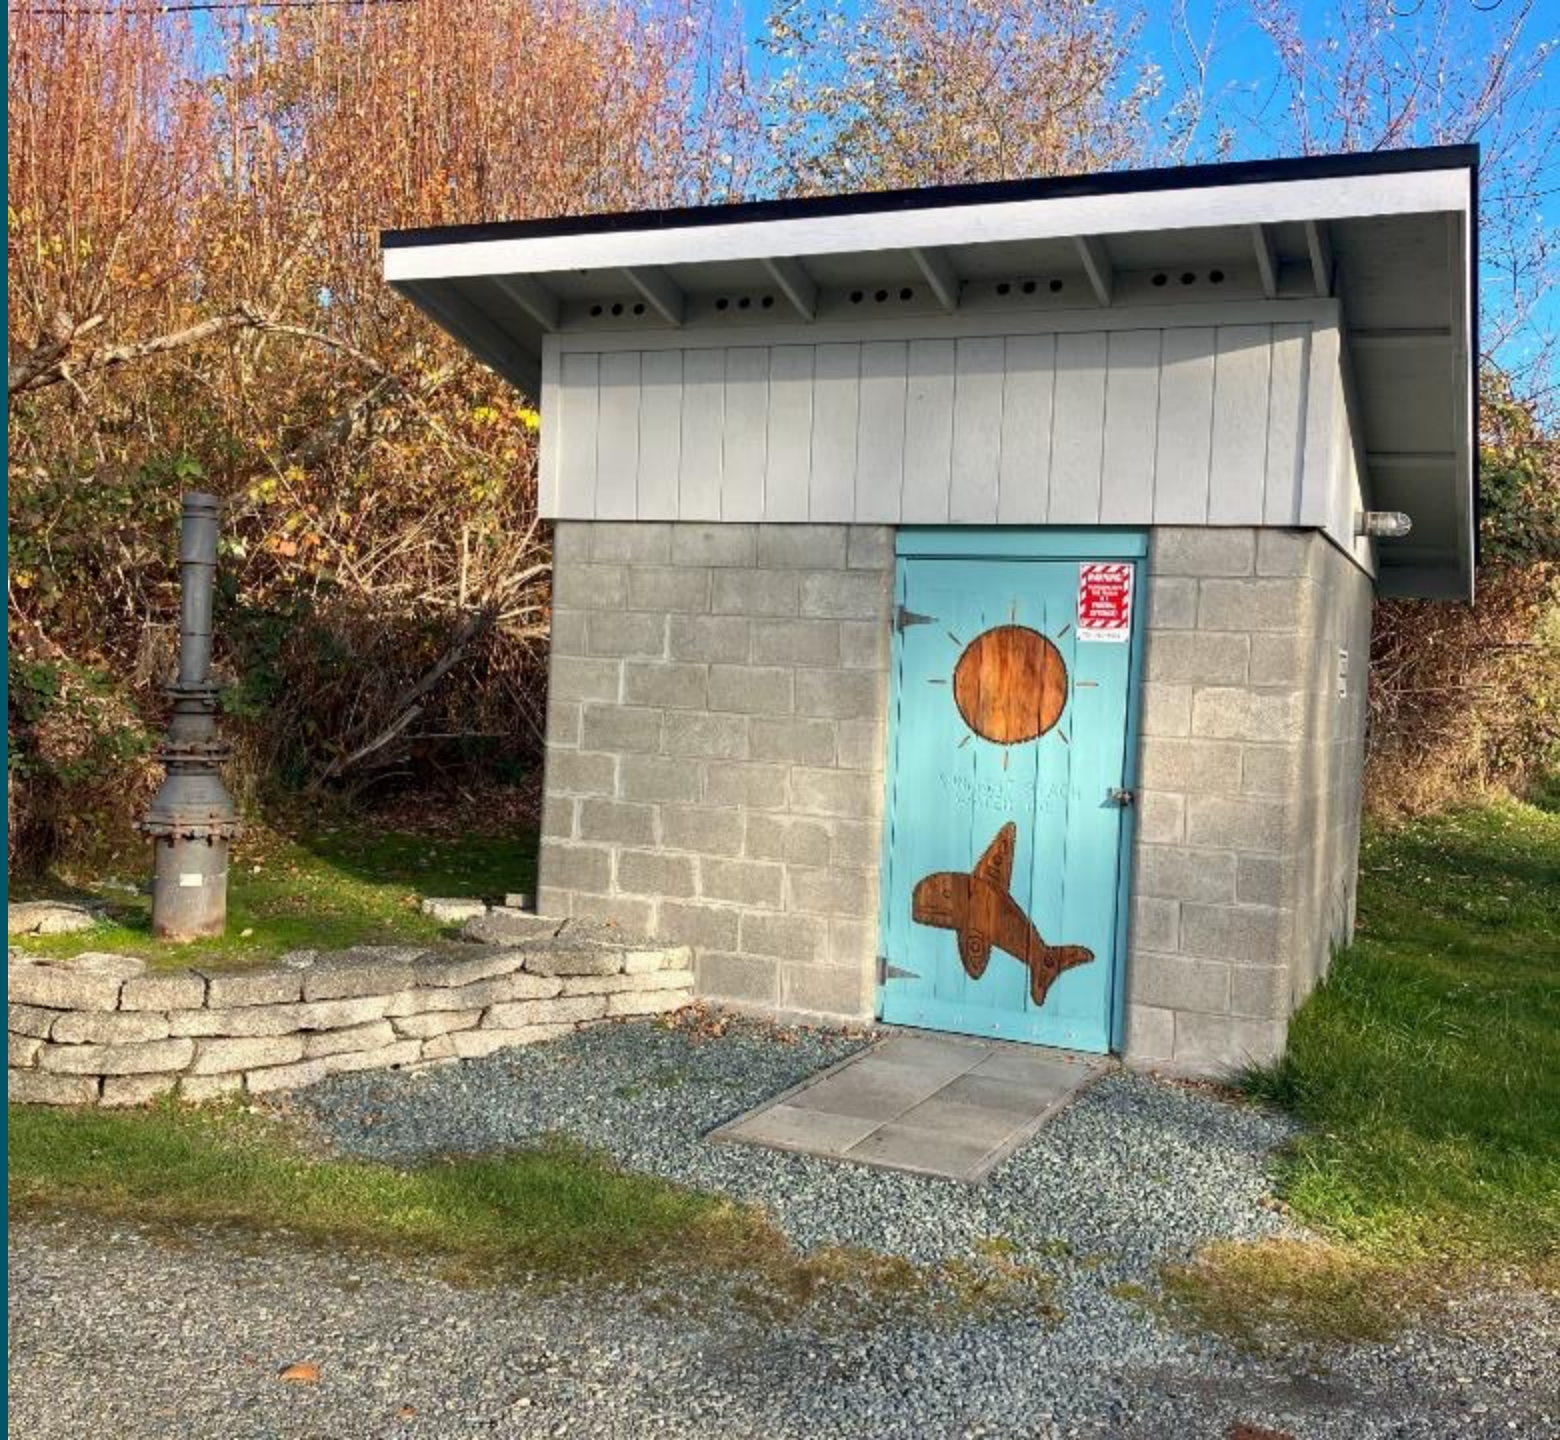
SBWA Water System Well House

- Two Groundwater Wells
 - Well 1 (S01, Disconnected/No longer in use)
 - 10-inch Well
 - 25 feet deep
 - 35 gpm capacity
 - Well 2 (S02, Active)
 - 10-inch Well
 - 21 feet deep
 - 35 gpm capacity
 - Well house at corner of Old Henry Lane and Sunlight Beach Road
 - Does not require treatment
- Intertie with SBV-SLB HOA Water System

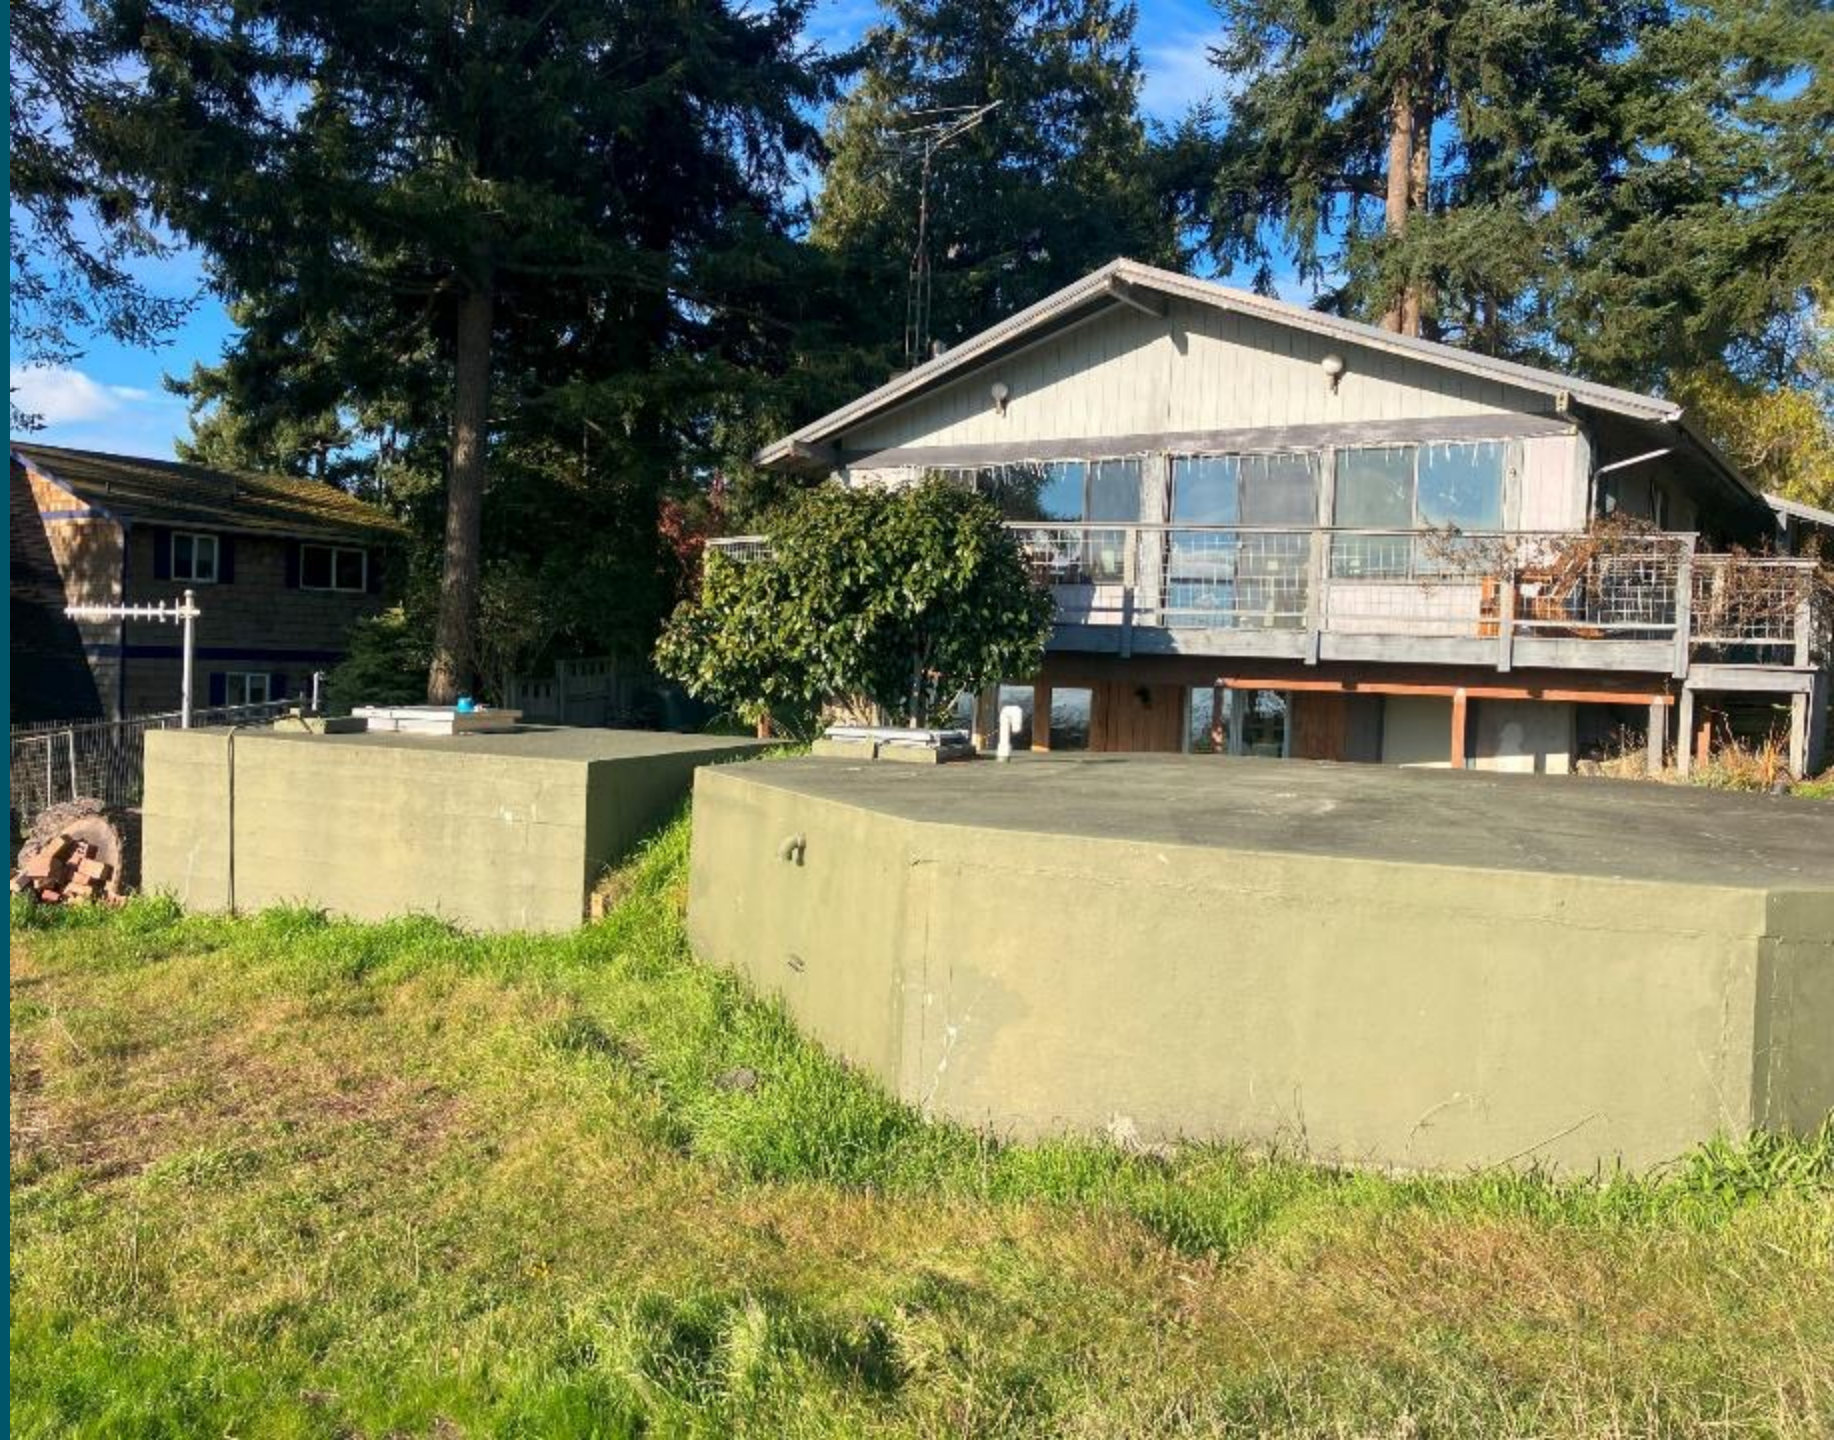
SBWA Water System Storage Tanks

- Two Water Storage Tanks
 - Tank 1
 - 9,000 gallons
 - Rectangular reinforced concrete tank
 - Tank 2
 - 25,000 gallons
 - Hexagonal reinforced concrete tank
 - Total Storage Capacity = 34,000 gallons
 - Located on property between Sun Vista Circle and Kohlwes property
