December 2023
Sun Vista/Sunlight Beach Water Consolidation Feasibility Study

Task 1 Summary Memorandum – Evaluation of Existing Sunlight Beach Water Association Water System

Prepared for:
Sunlight Beach Water Association

**Re: Sun Vista/Sunlight Beach Water Consolidation Feasibility Study
Task 1: Evaluation of Existing Sunlight Beach Water Association Water System**

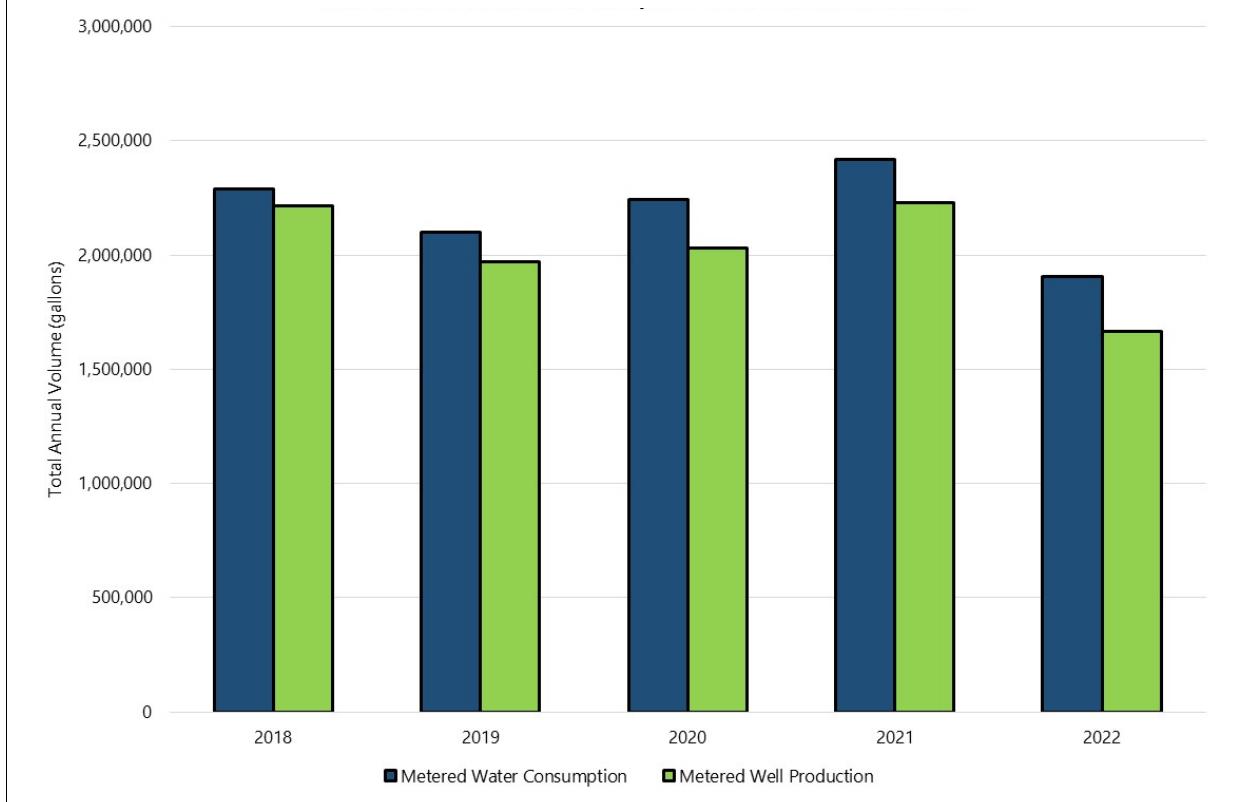
Figure 3
SBWA Metered Production vs. Metered Consumption

Table 5 provides a comparison of annual well production metered on the discharge pipe from the groundwater wells with authorized use measured at customer meters and tracked by SBWA for the period of 2019 through 2022. Figure 3 includes a graph comparing metered water production with metered customer water consumption. The data indicate that for the SBWA Water System, the total annual volume of metered customer water use has exceeded the annual volume of metered well production during each of the last 4 years. That exceedance ranged from 6.5% in 2019 to 14.4% in 2022. Because it is impossible to consume more water than is delivered to the system by the groundwater wells, the results suggest that there is likely a discrepancy between metering of customer water use and well production that will need to be resolved to accurately calculate DSL. The SBWA has indicated that the numbers presented in Table 5 reflect an inaccurate well production meter. That meter was replaced in 2021. SBWA will continue to review metering data to ensure that their well production meter and customer service meters are accurate and read consistently so that DSL can be accurately calculated.

1. A negative DSL number indicates that more water was metered at customer water meters (authorized consumption) than was metered at the groundwater wells. Because it is impossible to consume more water than is supplied to the system by the wells, the results suggest that there is a discrepancy in metering that needs to be resolved.
