November 2023
Sun Vista/Sunlight Beach Water Consolidation Feasibility Study

Task 1 Summary Memorandum – Evaluation of Existing Sun Vista/Sunlight Beach Homeowner’s Association Water System

Prepared for:
Sun Vista/Sunlight Beach Homeowner’s Association

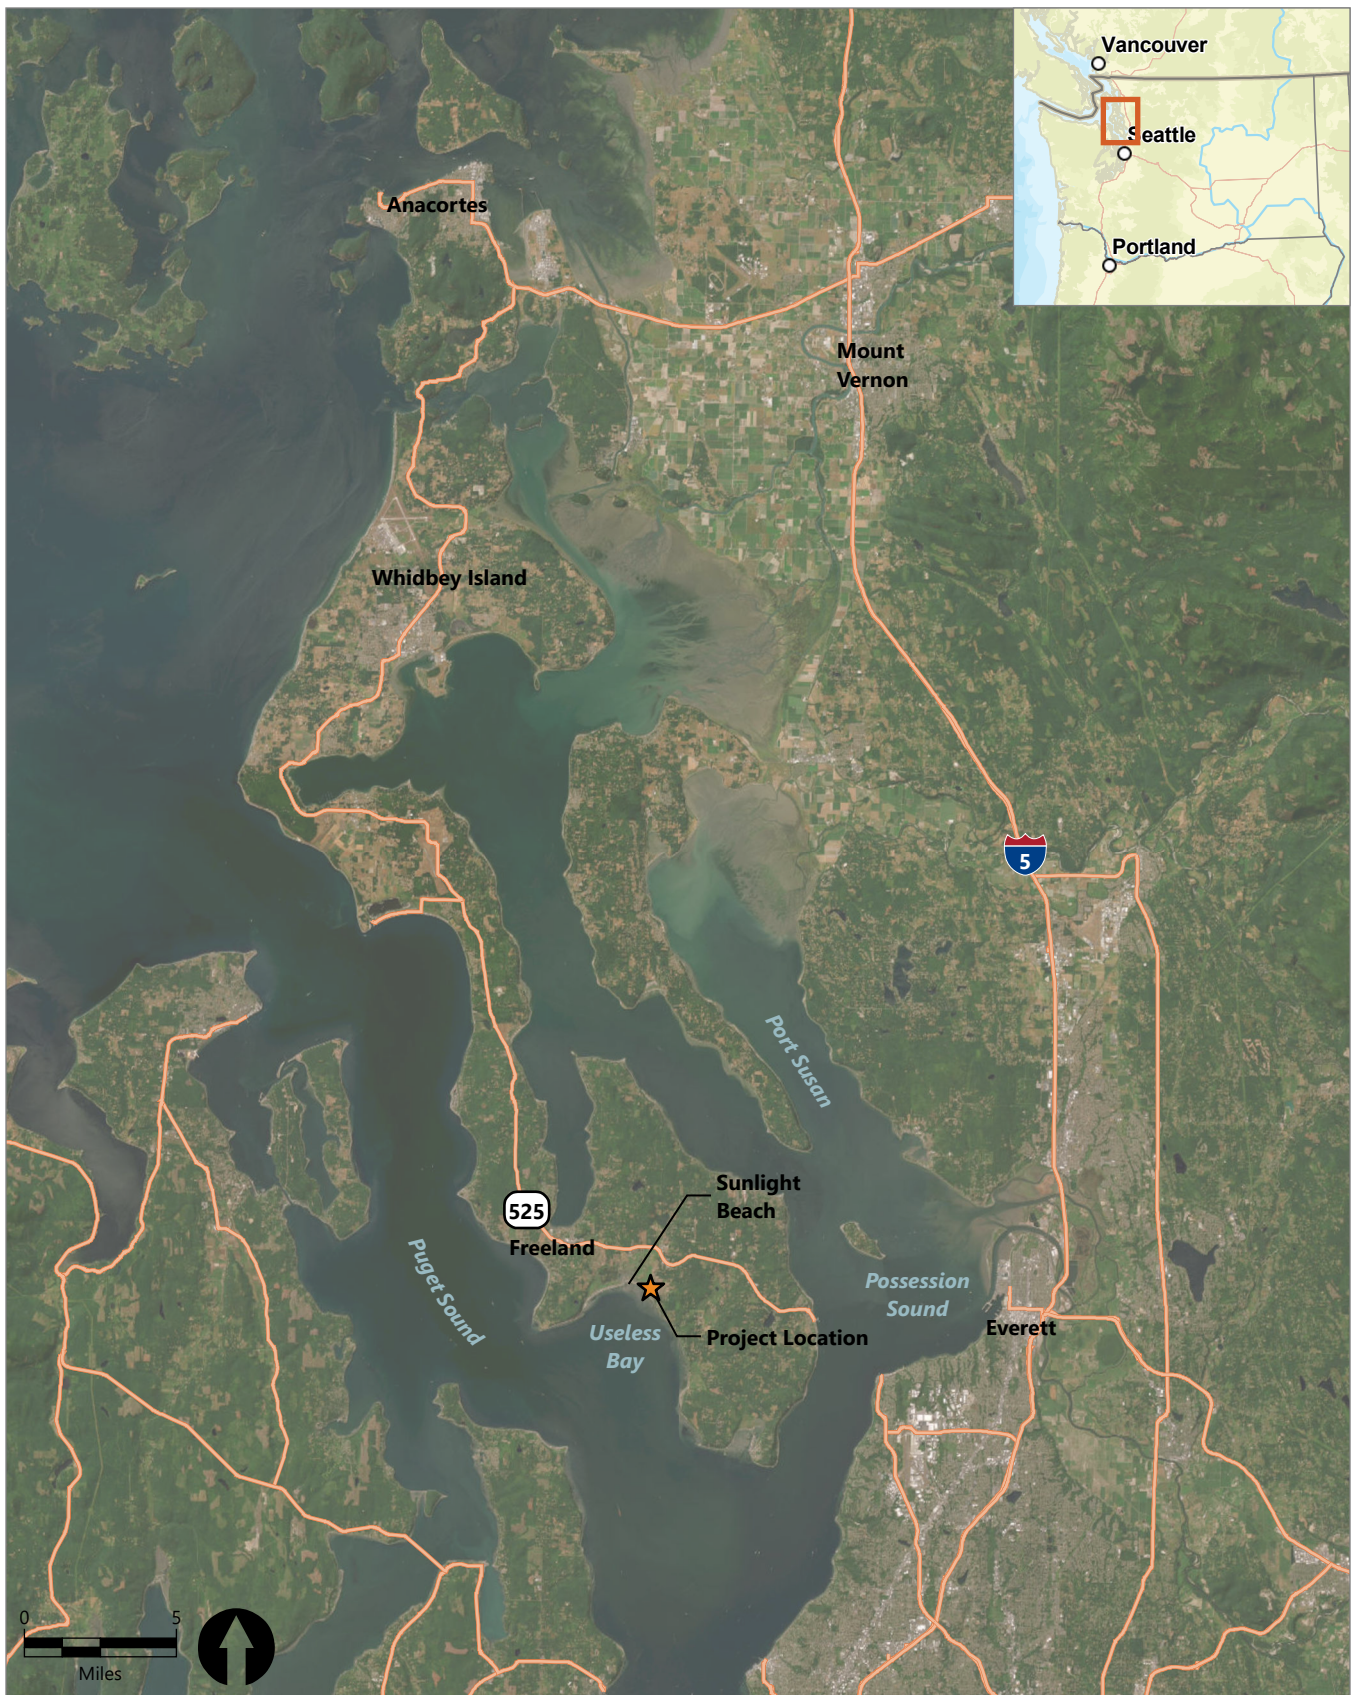
Figure 1
Location Map

The SV-SLB HOA Water System is located on Whidbey Island in a rural residential area north and east of Useless Bay. The system serves properties along Sunlight Beach and within the Sun Vista Development, as shown in Figure 1. The water system's service area and infrastructure overlap with the service area and water system infrastructure operated by the SBWA. The water system's service area also overlaps with the water system that serves Olympic Marine View Divisions 1 and 2. The SV-SLB HOA Water System comprises the following key pieces of infrastructure, shown in Figure 2:
